## Rock Slopes Stability Analysis along the Road of (Al-Rabban Hormizd) Monastery in Alqosh Anticline, Northern Iraq

The aims of the current study include slope stability analysis conducted by kinematic analysis and Slope Mass Rating (SMR) at six selected stations on the road to (Al-Rabban Hormizd) Monastery located at Alqosh anticline, northern Iraq. The current study shows that station (1) has the possibility of two cases of direct toppling by intersection (J1) with both bedding plane (So) and (J3), both of which are stable conditions. Station (2) shows two possible cases: planner sliding on (J2), which is a bad and unstable condition. The second possible case is direct toppling from the intersection of (J1) with (J3), which is a good and stable condition. Station (3) shows two possible cases; the first is the planner sliding of (J2) with an (SMR) value of (23), so it is bad and unstable. The second is the wedge sliding from the intersection of (J2) with (J3), which is a good and stable. At station (4), three possible failure cases appeared. The first is planner sliding on (J1), which is bad and unstable. The second possible case is the wedge sliding from the intersection of (J1

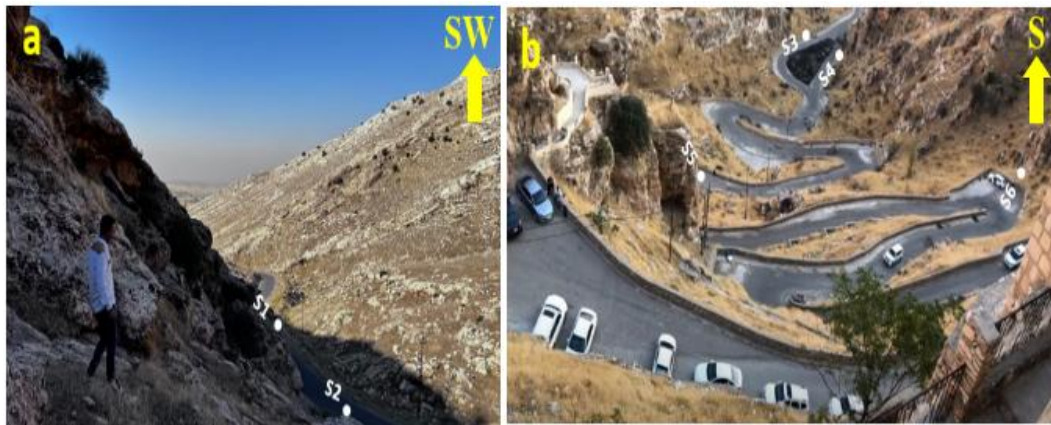
Fig. 3: Location of stations (a) the stations before the Monastery Gate taken from the top of the second station, (b) the stations after the gate taken from the top of the monastery terraces.

The slope stability analyses are distributed at six stations in the study area, which are chosen based on the occurrence or possibility of failure; two stations are before the gate of the monastery and four stations after the gate of the monastery. These slopes appear as a result of the mechanical cutting of the road. To find the Unconfined Compressive Strength (UCS), the samples are cut and prepared in a regular geometric shape to conduct the Point Load Test for easy sample preparation. Table 1 shows the results of the compressive strength test.

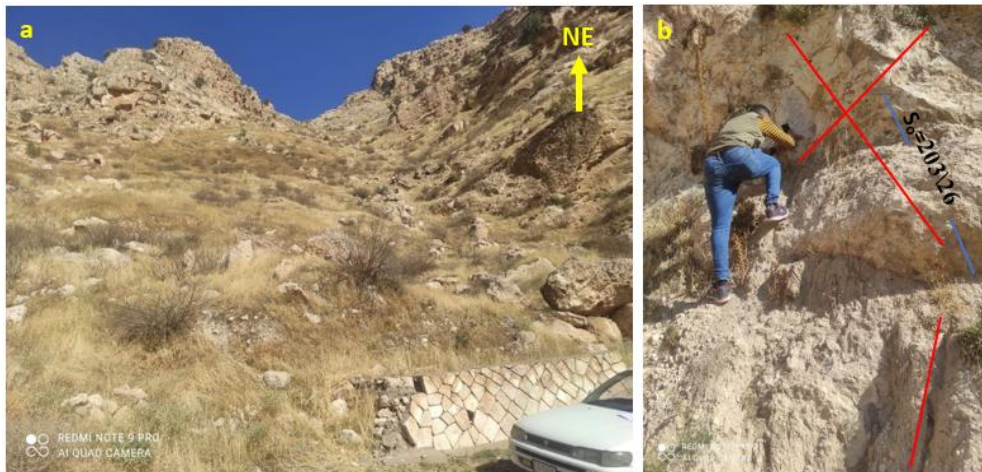
Fig. 10: Station (5): (a) Front view of the station showing part of the retaining wall destroyed by blocks falling from the top of the station, (b) Discontinuities in the station.

Station (5) has two possible failures; the first is wedge sliding from the intersection of (J1 with J2) in the direction (269°) with (SMR) value of (65); so it is a good and stable case that support occasionally, while the second is the flexural toppling on (J3) in the direction (227°) with (SMR) value of (52); it is a normal and partially stable case that requires a systematic support by concrete.

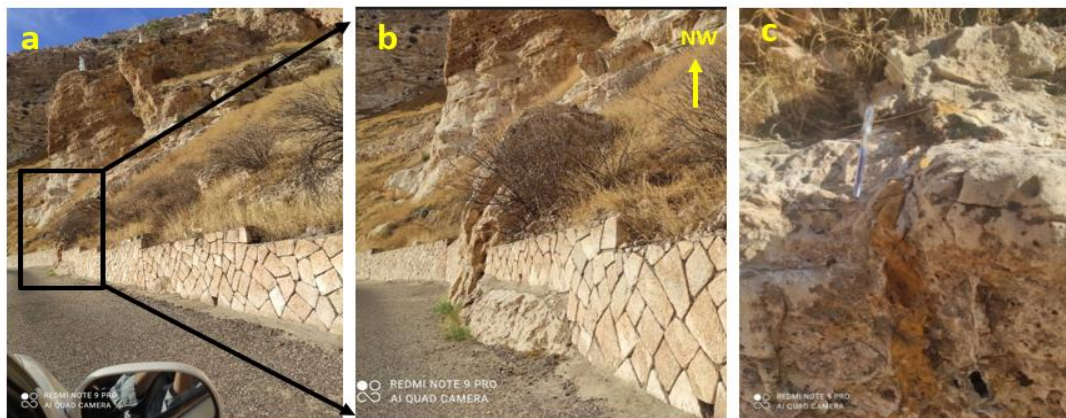
Fig. 11: Station (6), (a) Side view of the station. (b) Part of the station showing part of the retaining wall destroyed by blocks falling from the upper part. (c) The chert veins showing a thickness of 7.0 cm.

Finally, there are also two possible failures at Station (6); the first is least stable, representing planar sliding on (J3) in the direction of (142°) because its direction is inclined in the same direction as the slope in some parts, which makes it a surface that helps to slide. (SMR) is (13), so it is a very bad and completely unstable, which requires support by (Reexcavation Walls); while the second possible failure is wedge sliding from the intersection of (J1 with J3), which gives (SMR) value of (56), and the intersection of (J2 with J3), whose (SMR) is (54); both are normal and partially stable cases that require support systematically by concrete.
