Riverbank Erosion Using GIS and Remote Sensing Along the Greater Zab River in Iraq

ABSTRACT

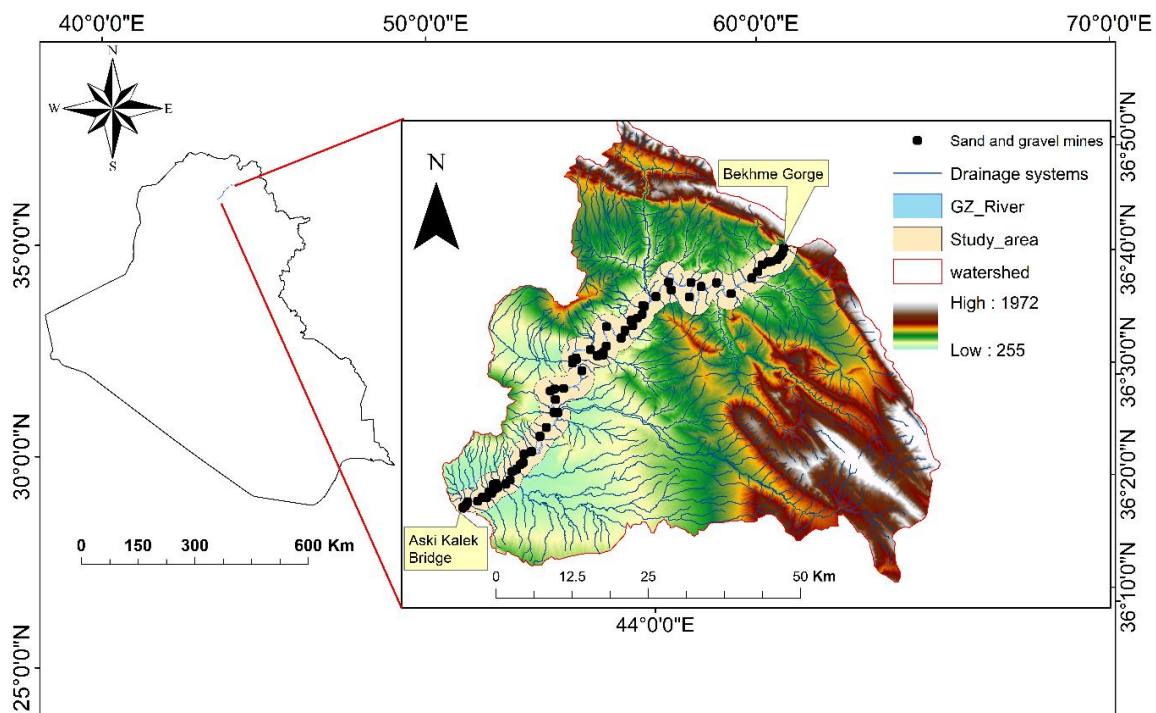
Fig. 1. Locations of GZR, drainage network systems, DEM values, and sand and gravel mines within the study area.

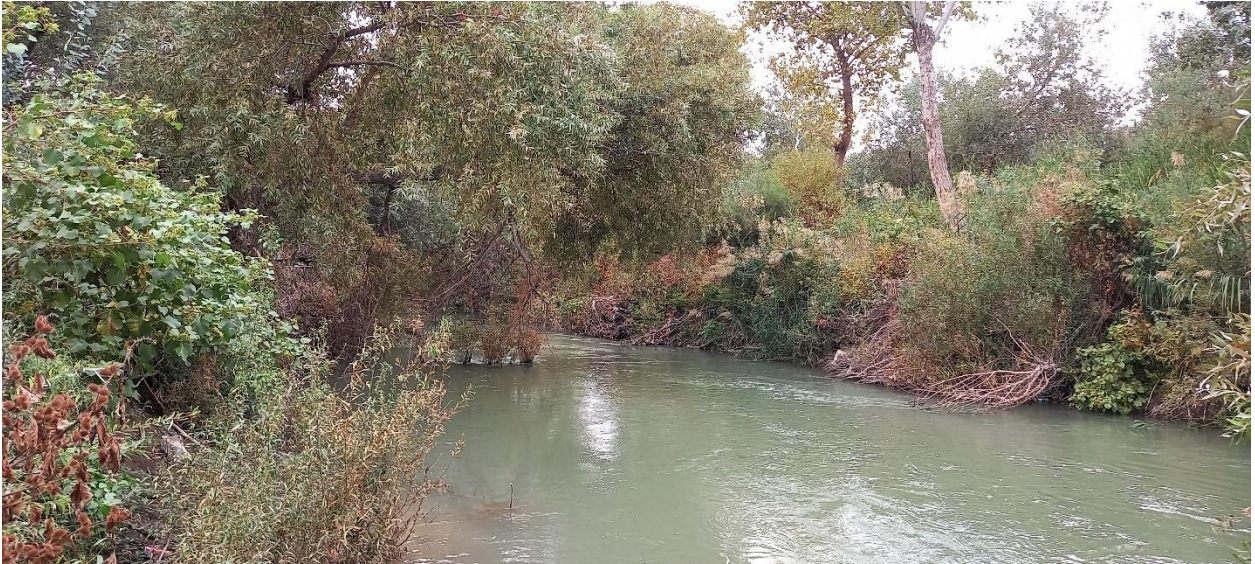
Plate 1. Surrounding riparian vegetation buffer at GZR (Photo by R. Hamad, 2023).

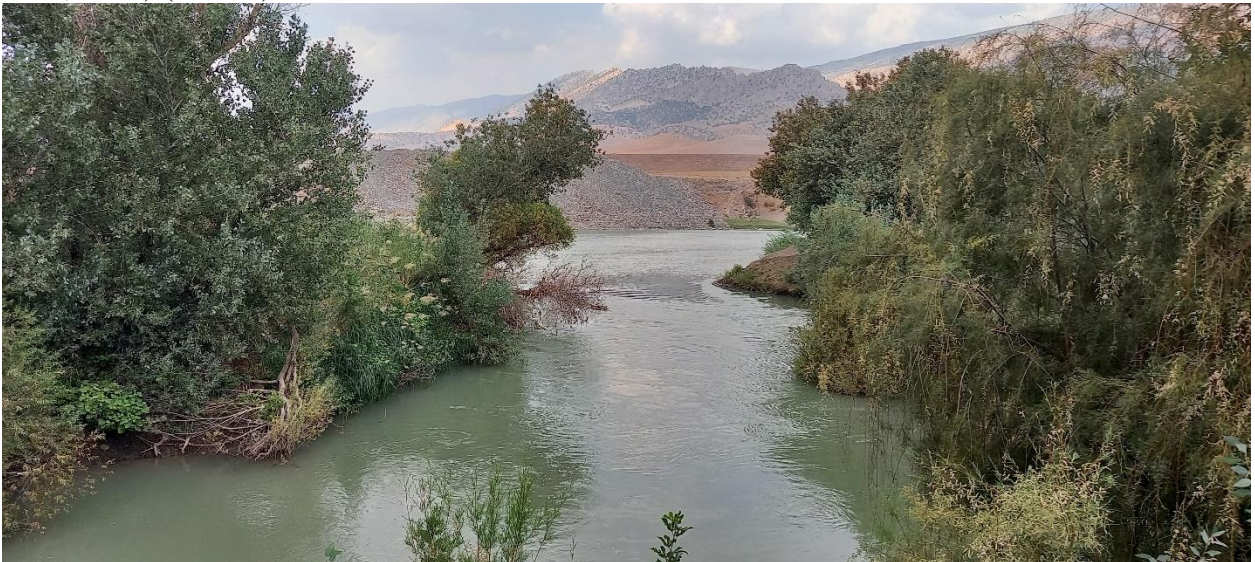
Tree roots and woody debris in the stream enhance its physical habitat diversity, stabilize sediments, and improve the water quality. Woody debris slows the flow of the water, forming eddies and pools where fish can rest, hide from scavengers, and avoid direct sunlight (Addy et al., 2016) (Plate 2).

Plate 2. Spatial structure of the environment that allows species to live and reproduce at GZR (Photo by R. Hamad, 2023).

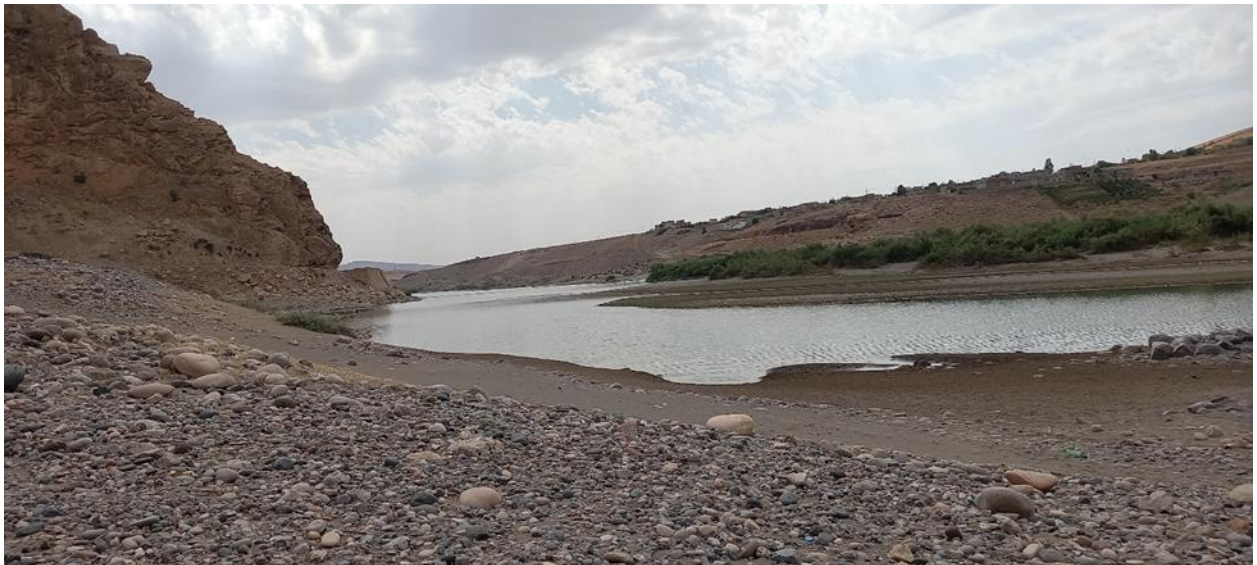
The main causes of bank erosion and accumulation are channel expansion, elongation of meander bends, lateral channel movements, and meander cutoff (Plate 3).

Plate 3. Erosion of banks and expansion of the aggregation channel at GZR (Photo by R. Hamad, 2023).

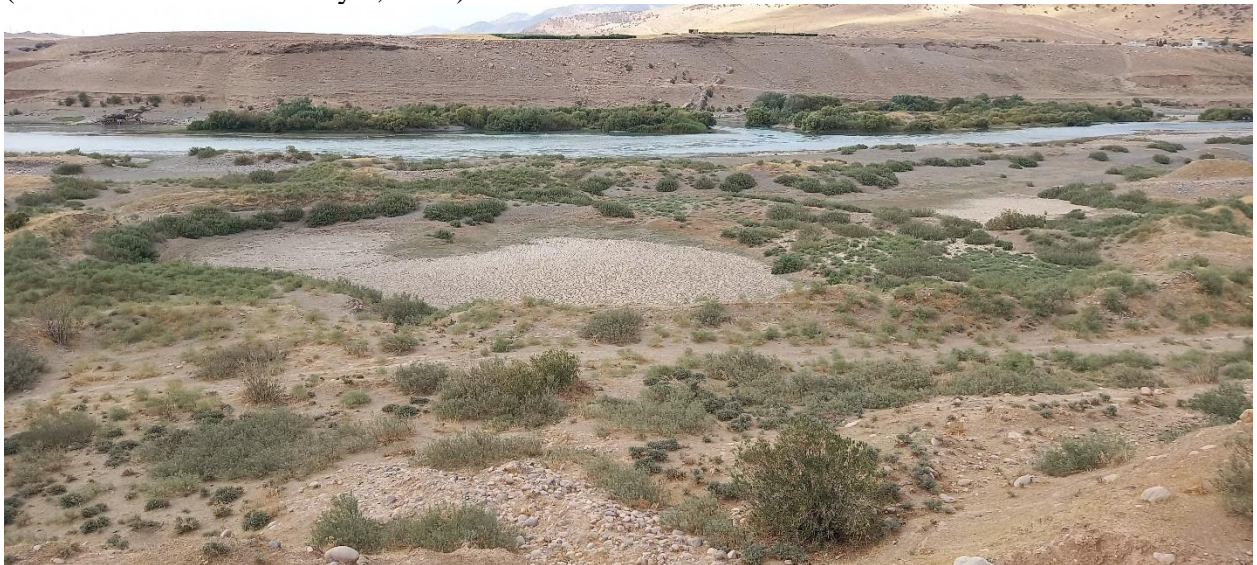
The mid bar is depicted in Plate (4), which developed as the stream's secondary flow swept and rolled sand, gravel, and small stones laterally across the stream's bed, and up the point bar's shallow and sloping floor (Semwal and Dutt Chauniyal, 2019).

Plate 4. Point bar at GZR (Photo by R. Hamad, 2023).

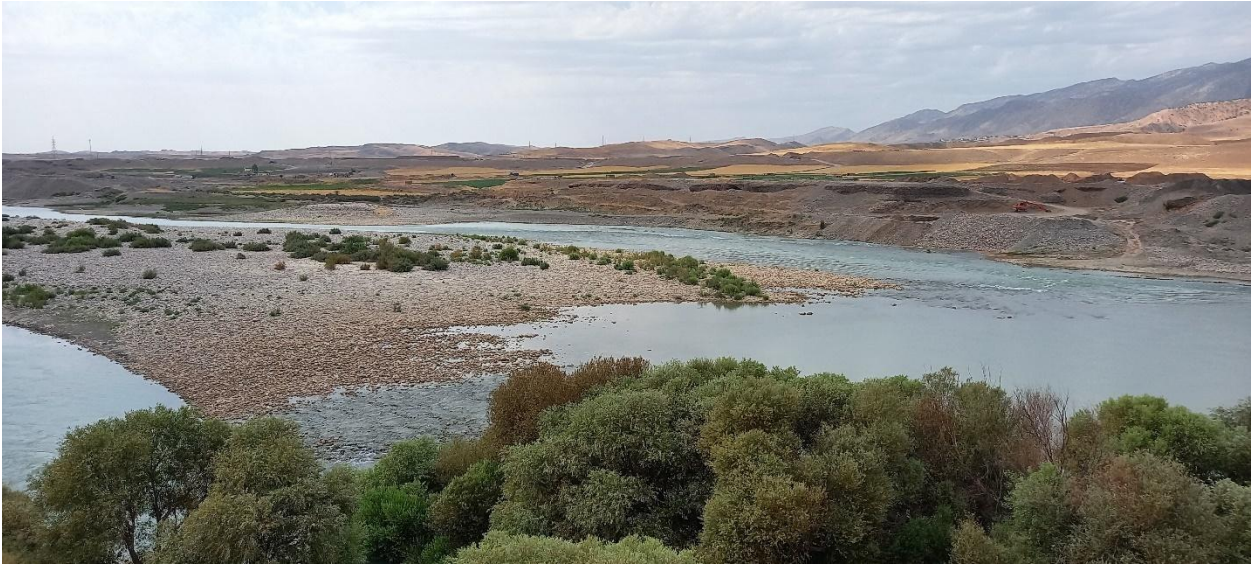
Another feature exposed in the area of interest was Riffles and pools, which develop when shallow water moves quickly over gravel or cobbles, breaking up the water's surface (Addy et al., 2016). The channel splits into two branches due to abrupt changes in gradient caused by riffle formation, and silt is dumped in the pool along the channel close to the bifurcation. There was a lengthy tail of gravel between the two dividing channels (Plate 5). Moreover, island bars frequently grow at riffle places and then emerge above the water as the water level drops (Semwal and Dutt Chauniyal, 2019).

Plate 5. Riffles at GZR (Photo by R. Hamad, 2023).

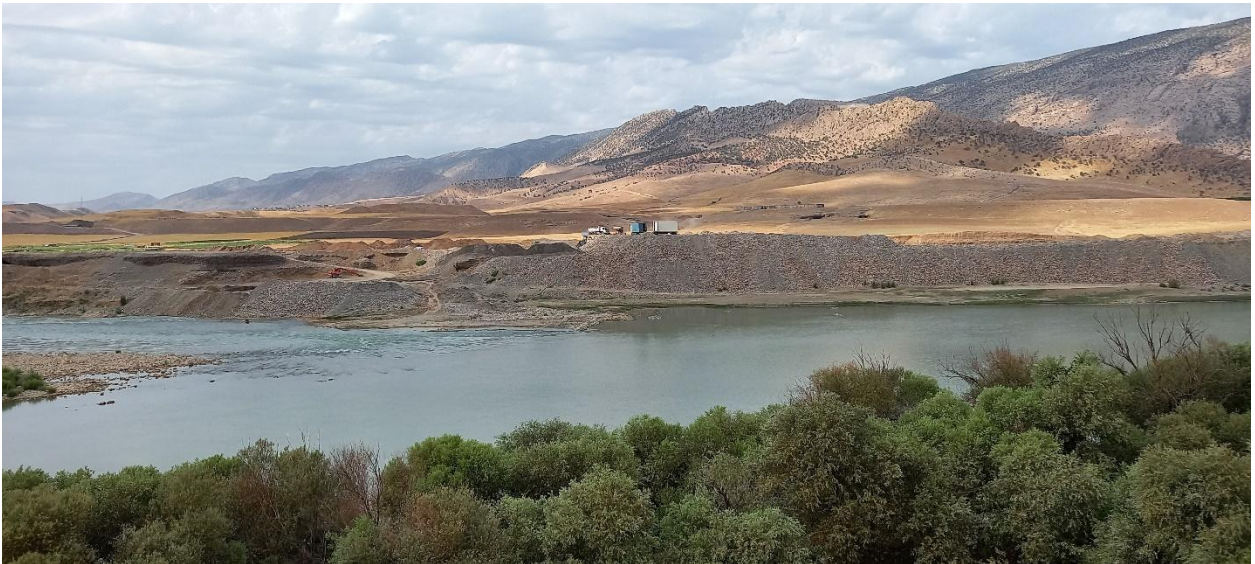
Plate 6. Splitting of GZR as a result of the excavation of sand and gravel (Photo by R. Hamad, 2023).

The geometry of rivers is dynamic and reacts to both natural and artificially induced activity. Sand mining can change the shape of rivers (Plate 6). Both the length and the width are subject to change (Smith and Winkley, 1996). Thus, human activities are more powerful than natural events such as floods, droughts, and landslides in causing changes in the river pattern (Hossain et al., 2013).

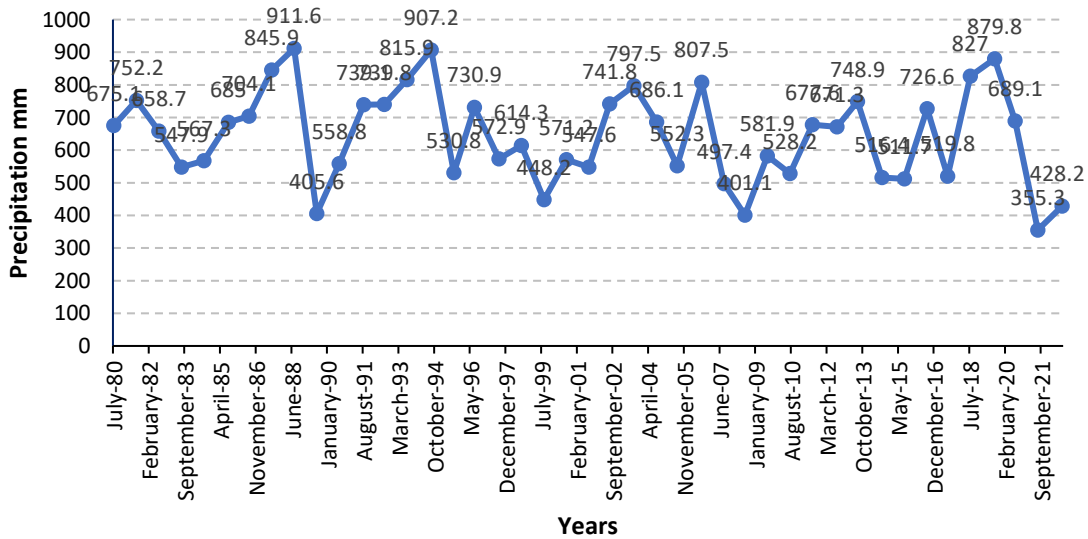
The total annual precipitation (1980–2022) is drawn as a graph based on the data downloaded from the Google Earth Engine (GEE). The years 1987, 1993, and 2019 had the highest totals of precipitation (911.6, 907.2, and 879.8 mm), respectively. On the other hand, the minimum total precipitation in 2021, 2008, and 1989 was (355.3, 401.0, and 405.6 mm), respectively (Fig. 2).

Fig. 2. Total precipitation (in mm) in any place within the research area (downloaded from the Google Earth Engine platform).

The first period, which lasted from the turn of the 20th century until the end of the 1980s, saw few human influences on the river and river morphology that was either in or very similar to its natural state. There was no fragmentation of the river, and the river also expanded. However, the river began to split, the number of islands increased, and the river's area shrank beginning in the 1990s. This is due to increasing human impacts, the extraction of more sand and gravel, the use of the river as a source of drinking water, and decreased rainfall, with the lowest recorded amount of 355.3 mm in 2021 (Fig. 2).

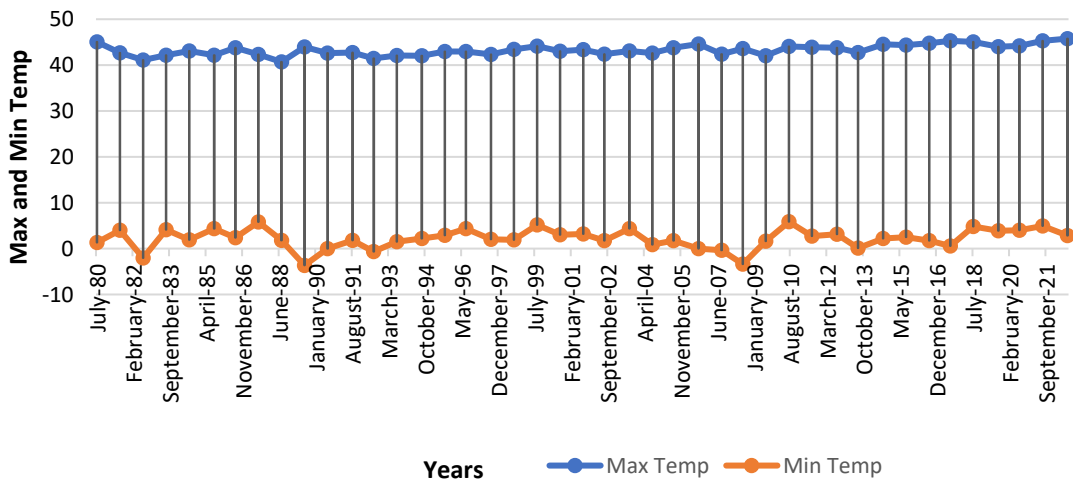
Fig. 3. Highest and lowest temperatures (in °C) for each winter and summer season for any place within the research area.

The research area's maximum and minimum temperatures for the same period, however, are shown in Figure 3. The highest recorded temperature was 45 °C in 1980, while the lowest recorded temperature was -3.6°C in 1989.

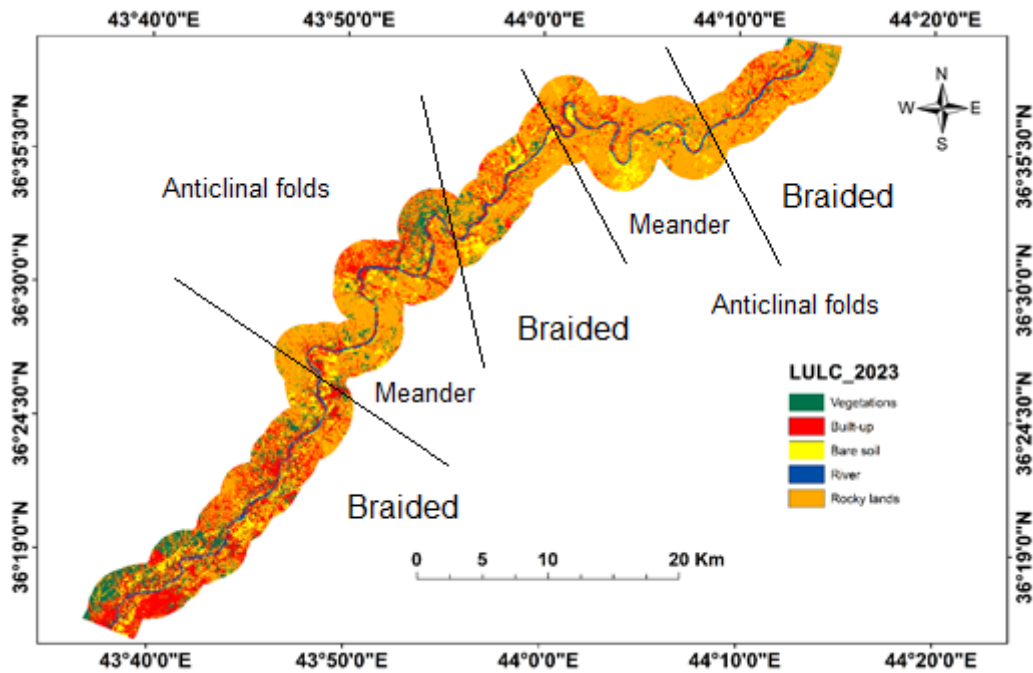
Random forest classification is used to categorize the images into several land cover classes to examine how land use and land cover have changed over time. The versatility, feature importance evaluation, decreased overfitting risk, and hyperparameter modification of random forest make it one of the most used machine learning techniques (Halabaku and Bytyçi, 2024). Since there were no built-up areas in the study area in 1972, the image from that year is divided into four classes, as opposed to the 2023 image, which is divided into five categories: cultivated land, built-up areas, barren soil, rocky lands, and rivers. Actual and periodic percentage of changes in land cover across the various periods between 1973 and 2023 were examined as seen in Figures 5 and 6, respectively.

The combined data derived from the analysis of satellite images are presented in maps. In contrast to image 1973, which had an accuracy assessment of 0.96 and a kappa coefficient of 0.94, image 2023 had a kappa coefficient of 0.91 and an accuracy assessment of 0.93.

Fig. 6. Random Forest classification of GZR in 2023.

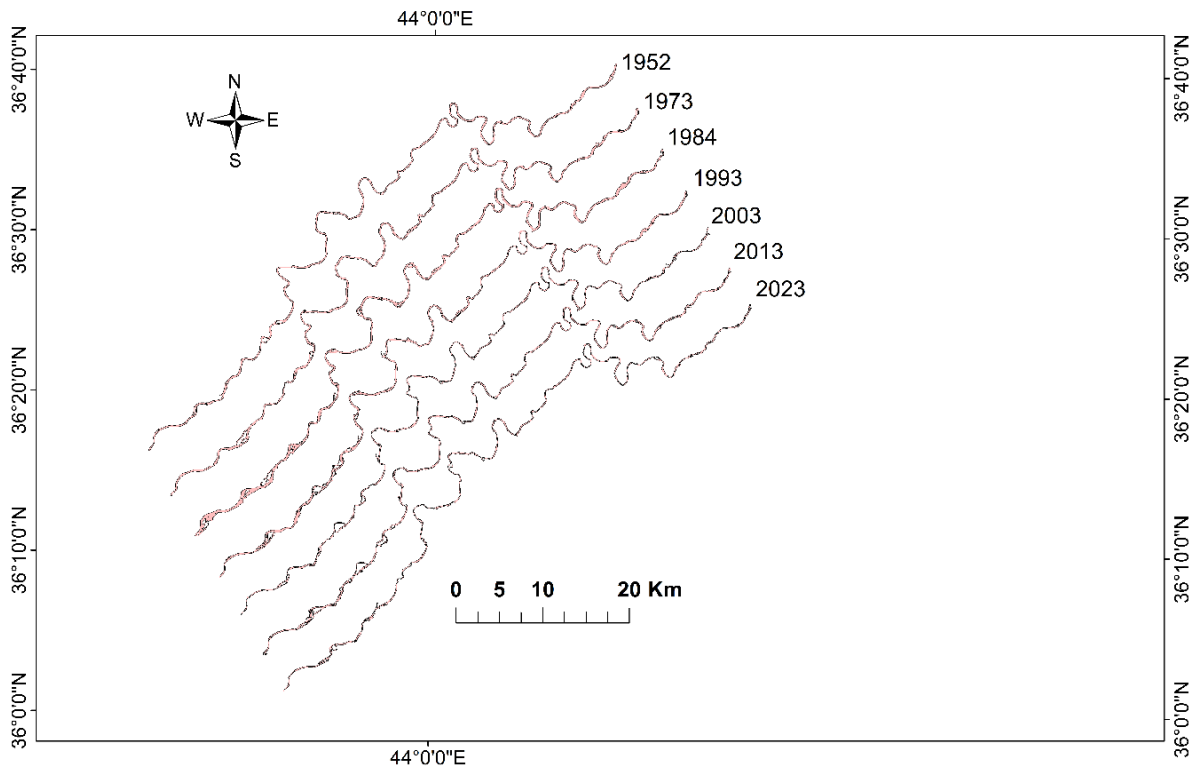
The GZR average channels were continuously altering between 1952 and 2023 according to the analysis of satellite images and a topographic map of the study area (Fig. 7). As a result of ongoing erosion and material deposition on its banks, the GZR will get shallower. This increases the likelihood that the river may flow in any direction, resulting in a lower channel gradient and larger sections (Sil et al., 2022).

Fig. 7. GZR's stretches saw a series of channel planform modifications for GZR flow from NE to SW between 1952 and 2023.

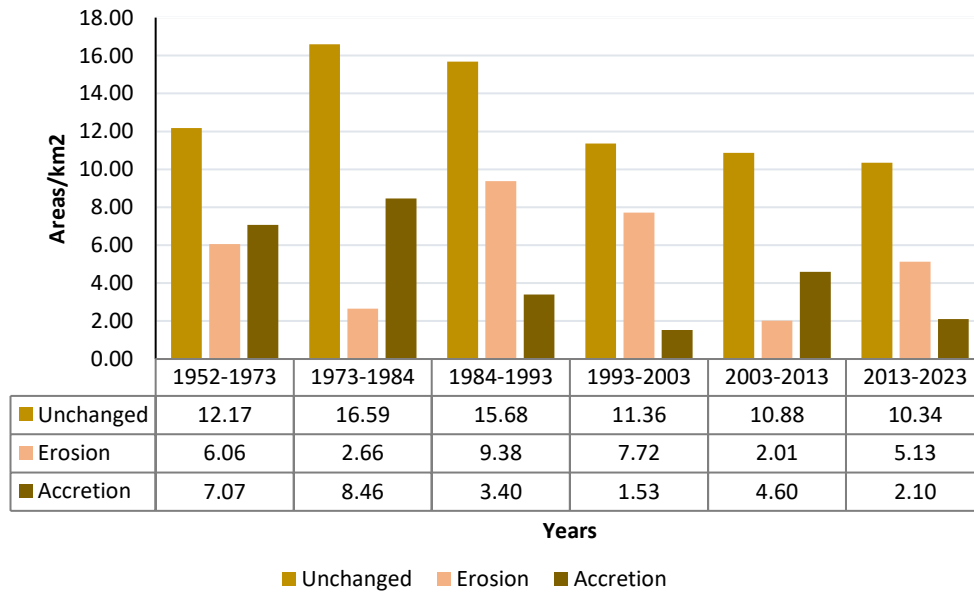
The study area's status has gotten worse as a result of direct and indirect human influences, and recently, it has also become dangerous for the continued existence of several infrastructures close to the bank. According to this analysis, there has been significant land loss along both riverbanks. Within 71 years, there was a total of 32.96 km² of erosion in the studied area, compared to 27.16 km² of newly formed land. Therefore, the research region suffered from substantial erosion from 1952 to 2023. The lowest unchanged area was 10.34 km² as revealed between 2013 and 2023 (Fig. 8). Consequently, throughout the past 71 years, the GZR exhibited a dynamic behavior in terms of erosion, aggregation, and unaltered area.

Fig. 8. GZR’s erosion, aggregation, and unchanged area between 1952 and 2023.

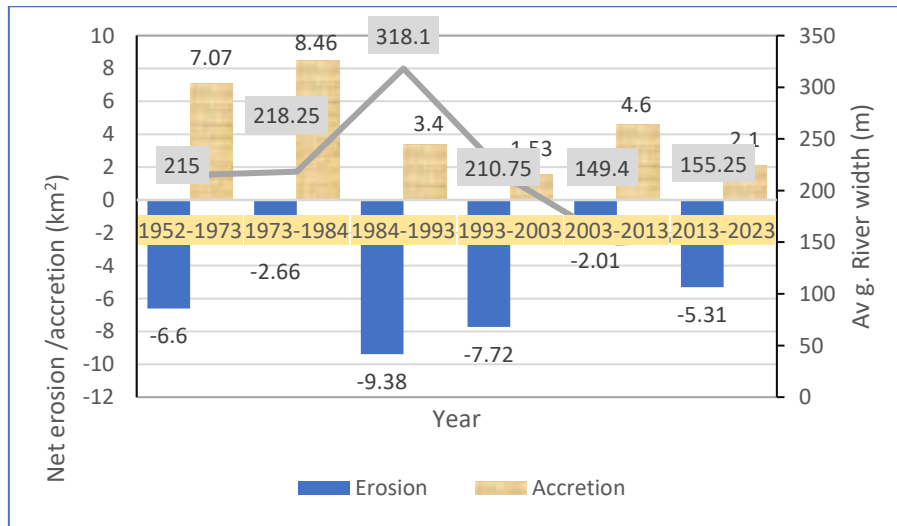
From 1993 to 2023, the average width gradually decreased (Table 3 and Fig. 9). It is important to note that the average width of the river also increased from around 215 to 318.1 m between 1952 and 1984. With the lowest maximum width of 245.4 m, the lowest minimum width of 29.8 m, and the smallest area of 12.64 km², the GZR experienced a significant narrowing in 2023.

Fig. 9. Changes in the average river width of GZR under a net aggregation and erosion between 1952 and 2023.

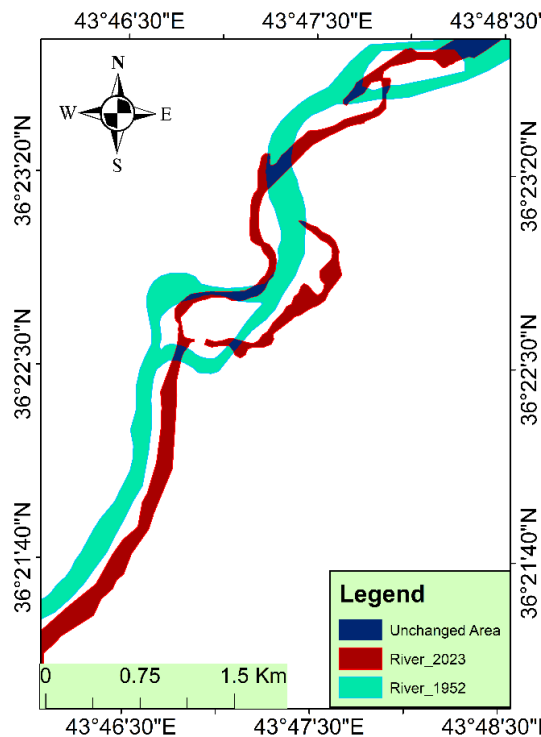
The year 2023 experienced the highest fragmentation with nine patches, but had four patches in 1993. The increasing number of patches indicates ecosystem degradation; thus, it is a sign of an unhealthy ecology in the GZR in 2023 (Fig. 10). Consequently, a variety of pressures will apply to the GZR, such as point-source and diffuse contamination from sand and gravel mining, providing drinking water, invasive plant and animal species, physical change, and climate change (Ritter et al., 2002).

Fig. 10. Part of fragmented GZR in 2023 with red color indicating channel shifting during the research period; the river in 1952 is colored by beryl green; the unaltered sections are colored by blue.

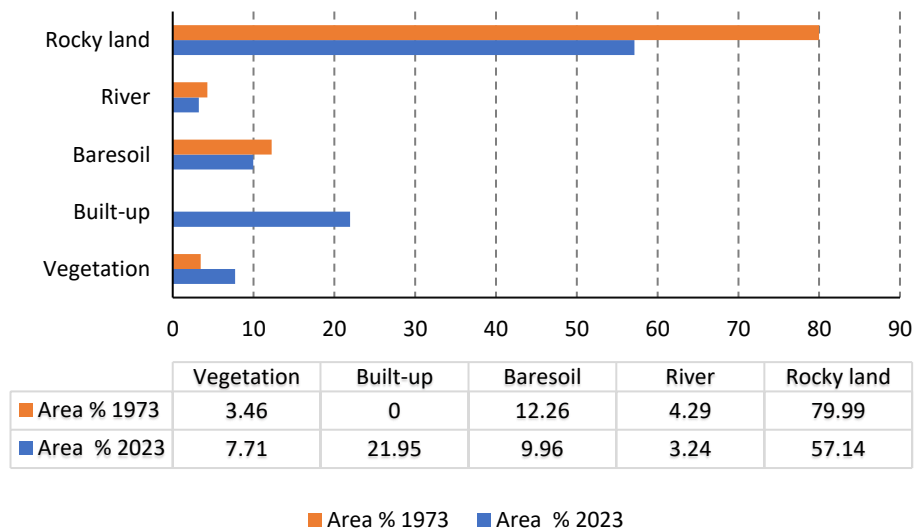
Two periods have been explained in this sub-section, which are 1973 and 2023. The categorization area statistics are shown in Figure (11), and percentages are used to measure the classed areas. The LULC maps are displayed in Figures 6 and 7 for two different time points. In the area of interest, rocky lands predominated the landscape in 1973 and 2023, taking up 79.99% and 57.14% of the total area respectively.

**Fig. 11. Percentage of changes in LULC within the study area between 1973 and 2023.**

A temporal analysis of land use and land cover shows that certain classes are growing while others are shrinking. For instance, built-up areas and vegetation land between 1973 and 2023 were rapidly developed from 0% and 3.46% to 21.95% and 7.71% respectively at the expense of other land classes including bare soil, river course and rocky lands (Fig. 11). Because

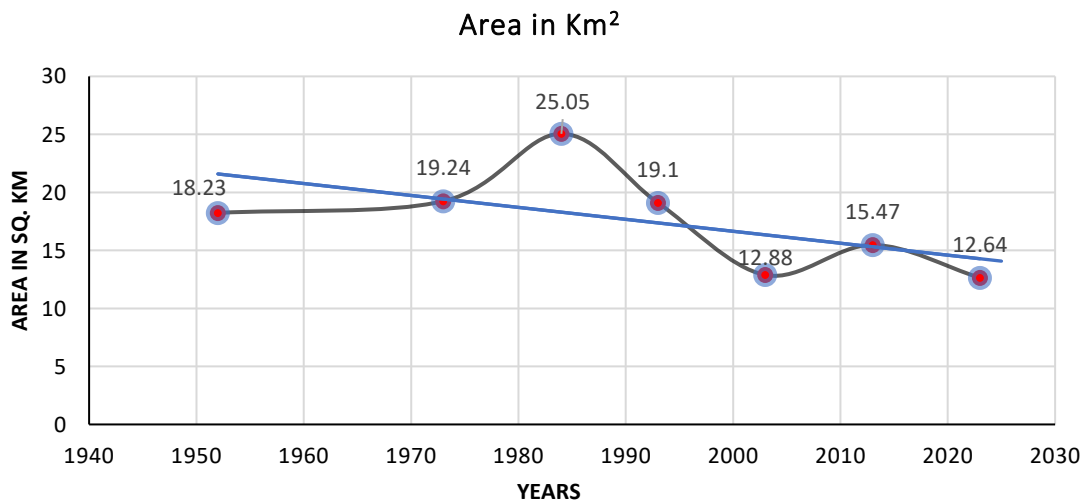
According to Table 2, erosion and aggregation are the main problems that are present in the alluvial plains of the GZR. The combined number of these problems is significant and concerning. In general, the Greater Zab riverine system underwent several alterations over the research period. For instance, there were significant positive changes between 1952 and 1984, when the area of the river increased from 18.23 km² to 25.05 km² respectively. The river area then underwent a severe decline between 1984 and 2003, shrinking to 12.88 km² in that year. Between 2003 and 2013, the river's area increased significantly, reaching 15.47 km². However, in 2023, the river's size began to decline once more, reaching 12.64 km², and recording the lowest area in the last seven decades (Fig. 12).

Fig. 12. Area (in km²) of the study area between 1952 and 2023.
